CASE STUDY

## BW FLEET MANAGEMENT FINDS SAFETY AND RELIABILITY

Samson 12-strand lines made with Dyneema® SK78 fiber replace failing jacketed mooring lines

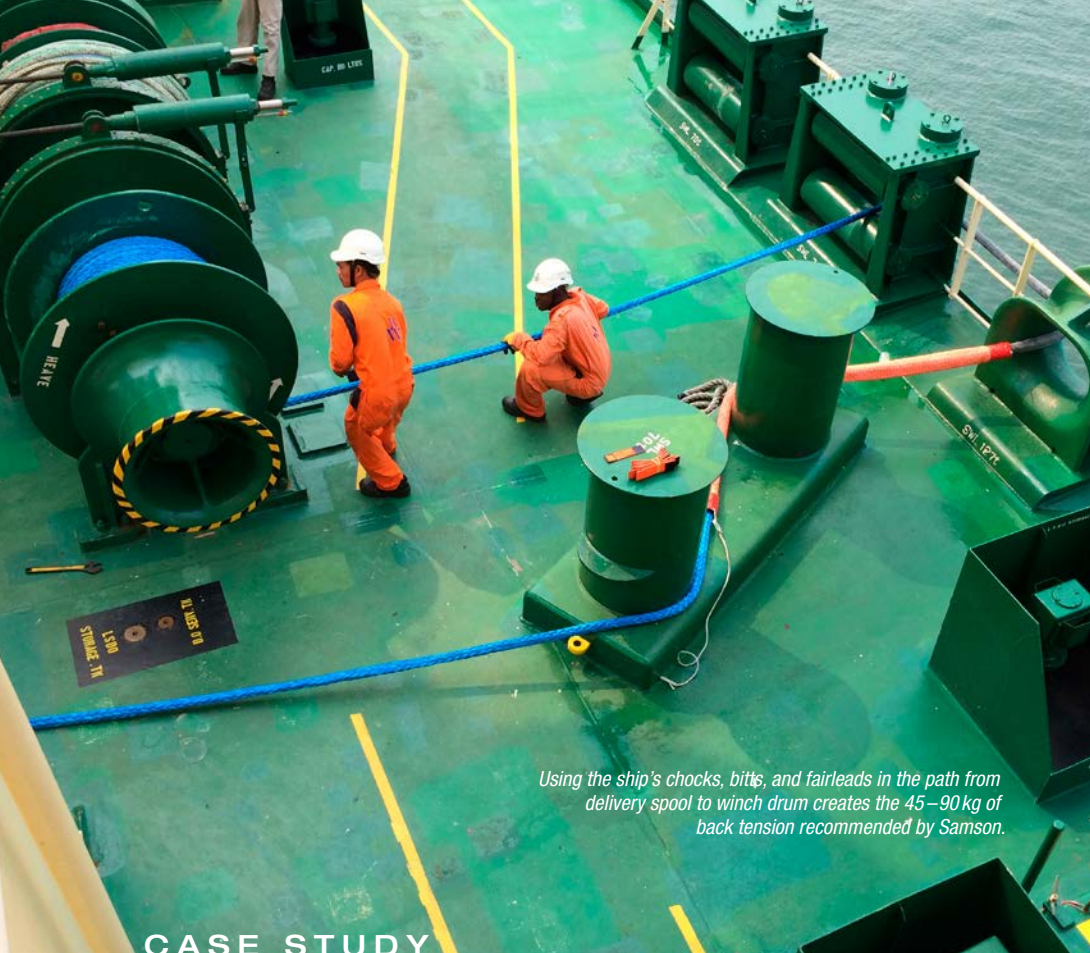
*Using the ship's chocks, bits, and fairleads in the path from delivery spool to winch drum creates the 45–90 kg of back tension recommended by Samson.*

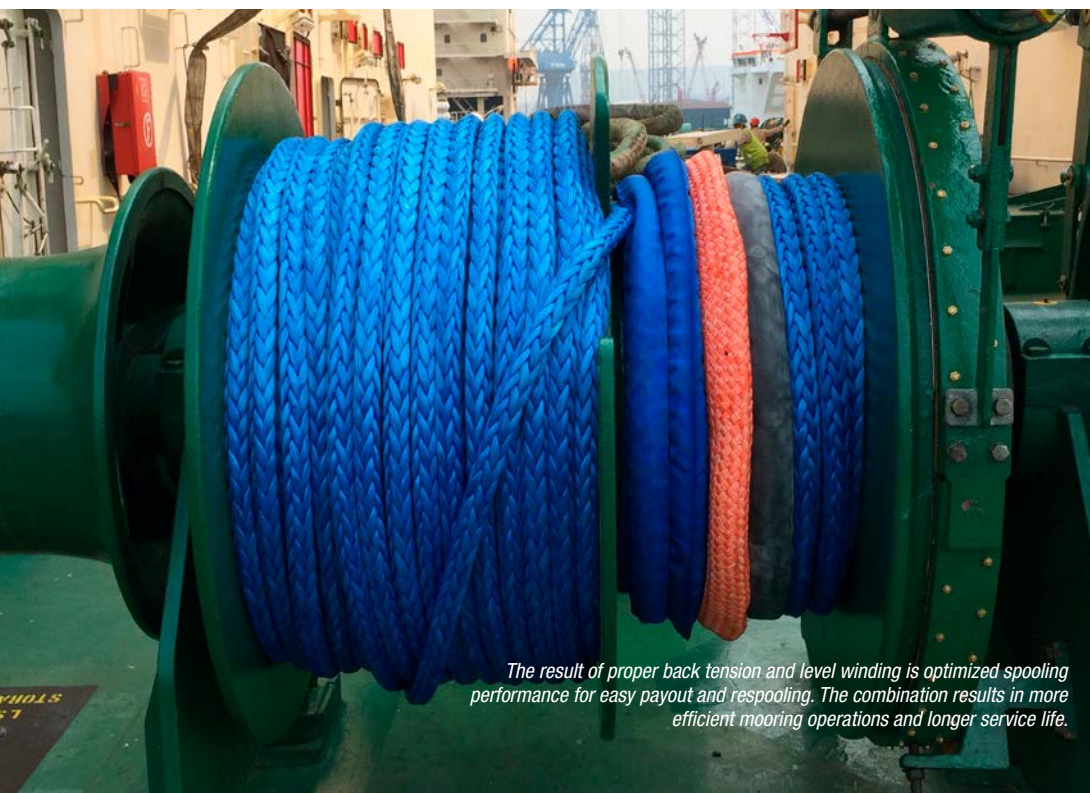
*The result of proper back tension and level winding is optimized spooling performance for easy payout and respooling. The combination results in more efficient mooring operations and longer service life.*

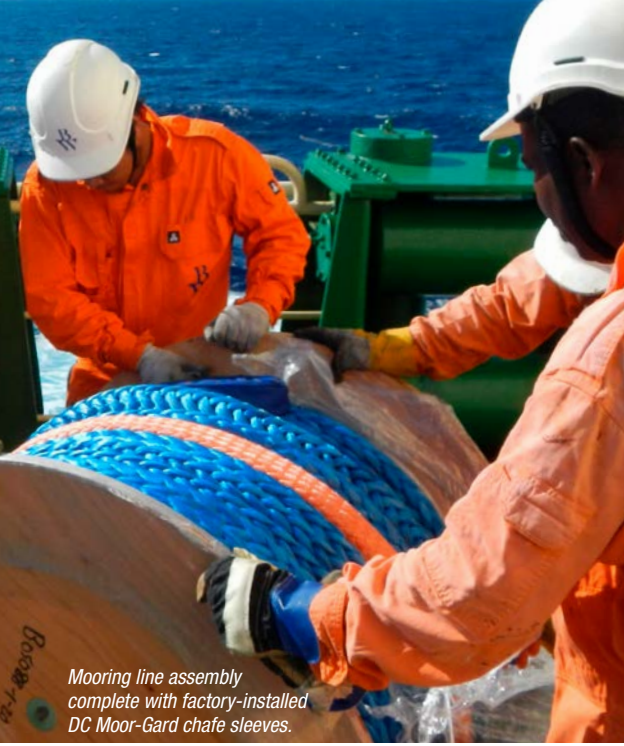
*Mooring line assembly complete with factory-installed DC Moor-Gard chafe sleeves.*

**CHAFE PROTECTION** In preparation for the installations, Samson collaborated with BW FM to perform initial vessel surveys to identify potential wear areas from deck hardware that would require some remedial work. The ropes were provided with appropriate chafe protection—*DC Moor-Gard™* chafe sleeves, which were installed at the factory prior to delivery.

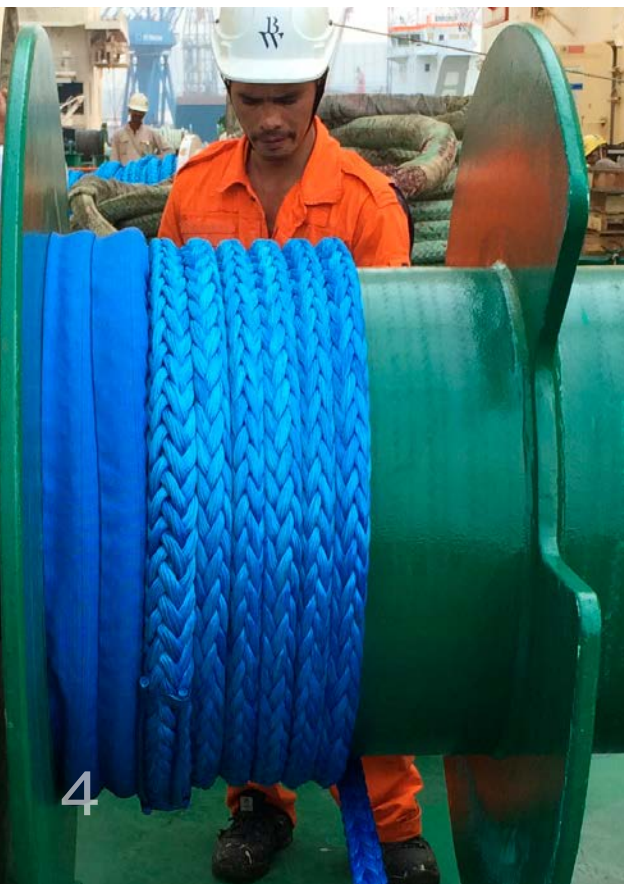
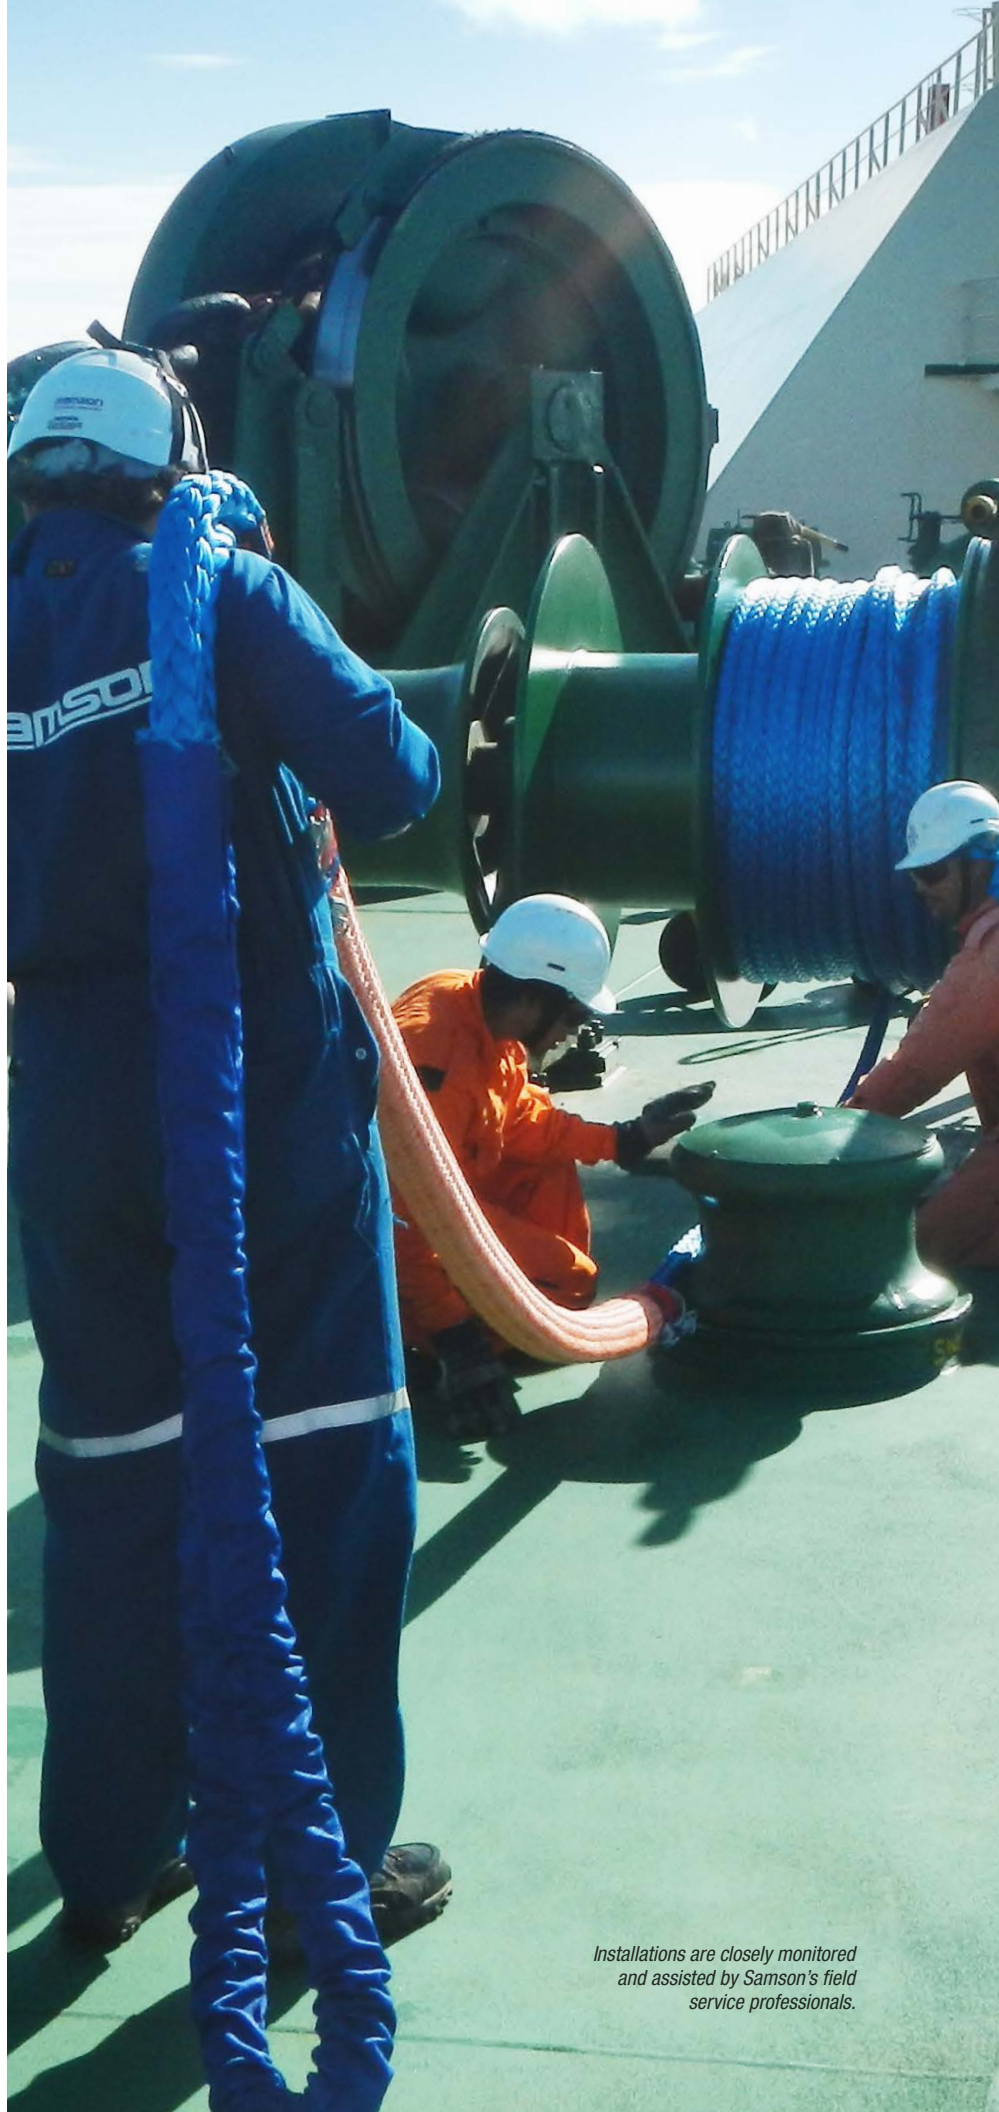
*Installations are closely monitored and assisted by Samson's field service professionals.*

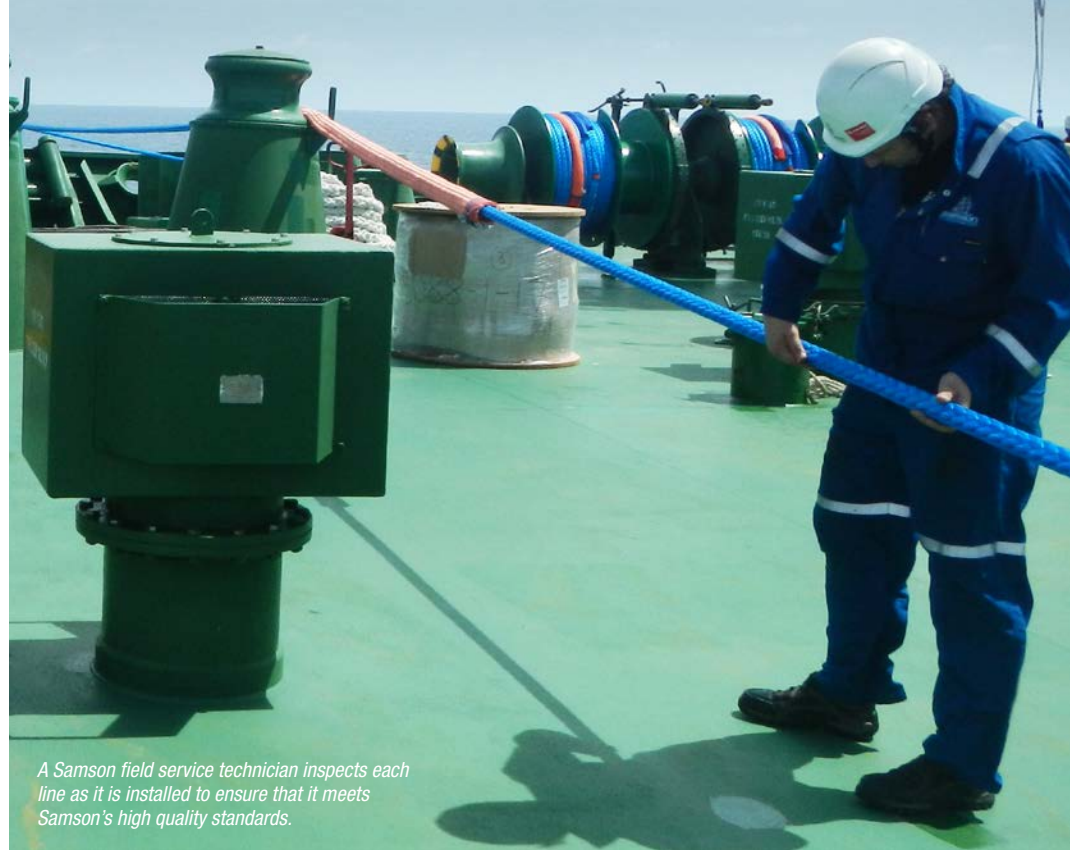
*A Samson field service technician inspects each line as it is installed to ensure that it meets Samson's high quality standards.*

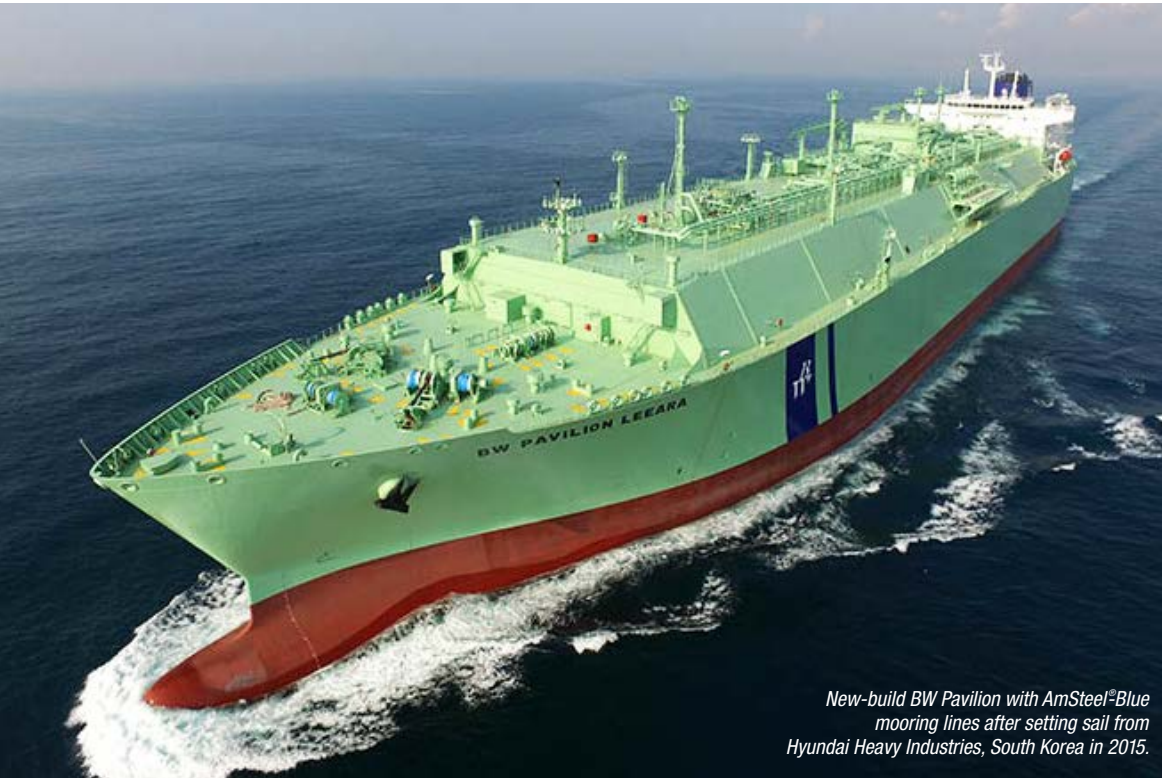
*New-build BW Pavilion with AmSteel®-Blue mooring lines after setting sail from Hyundai Heavy Industries, South Korea in 2015.*

Samson ropes have now been in service approximately two years on these BW FM vessels—in excess of 1,500 hours on average—with no damage reported on any vessel.
