## Effect of Ultraviolet Light on K-100™

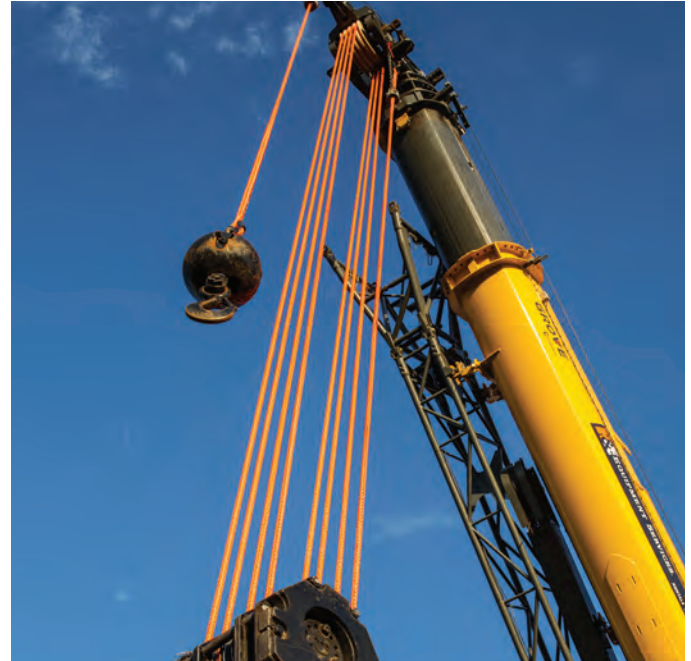
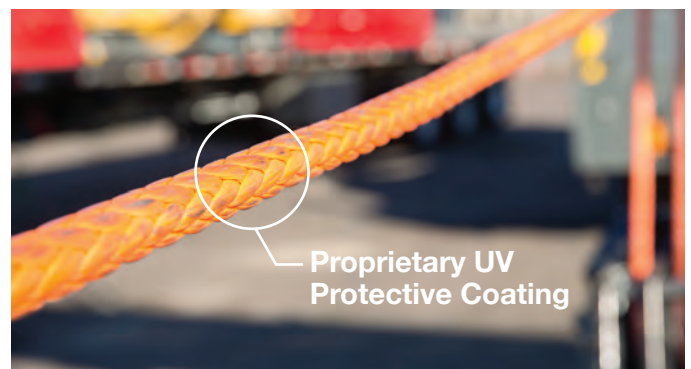
### UV Testing / Simulated Miami Florida Sun

To quantify the efficacy of Samson's proprietary coating on K-100, accelerated UV testing was conducted per ASTM G154: Standard Practice for Operating Fluorescent Ultraviolet (UV) Lamp Apparatus for Exposure of Nonmetallic Materials. Samples were tested in various intervals of simulated Miami, Florida sun; the worst case scenario being one year of constant exposure. Tensile break tests were conducted prior to and after the simulation. Test results confirmed the rope maintained 90% of new rope strength following exposure simulating one year in Miami sunlight.
